**SANITARY  
SURVEY CHAPUT  
HUGHES AREA  
(TECK TOWNSHIP)  
TOWN OF  
KIRKLAND LAKE  
NORTHEASTERN  
REGION**

SANITARY SURVEY  
CHAPUT HUGHES AREA (TECK TOWNSHIP)  
TOWN OF KIRKLAND LAKE  
NORTHEASTERN REGION

July 1975  
Municipal & Private Abatement  
Timmins District  
Northeastern Region

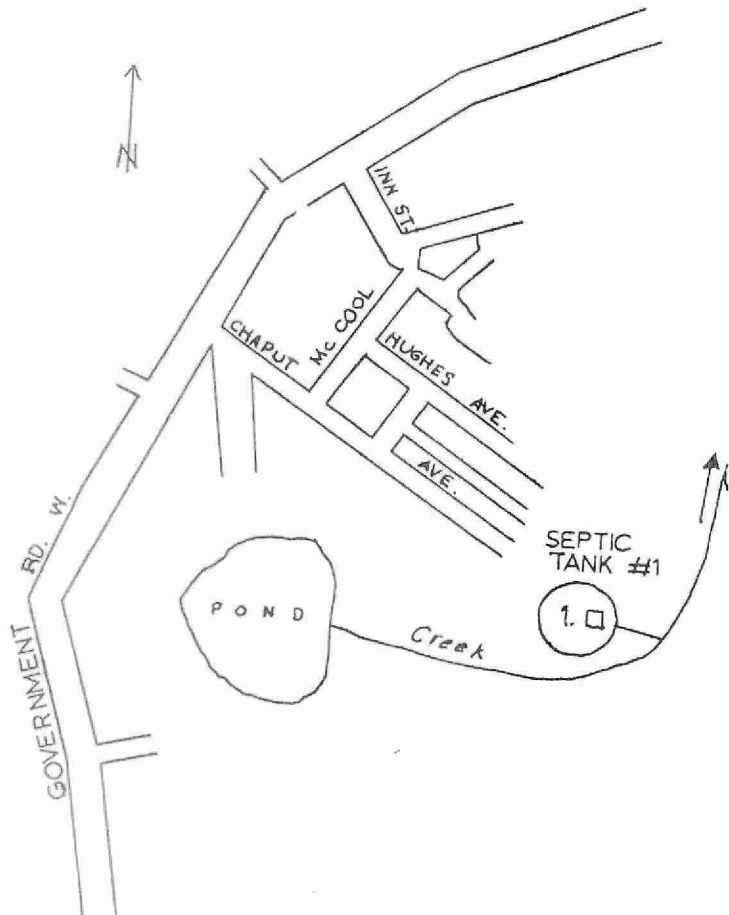
Northern portion of Chaput Hughes area served by septic tank #1

Septic tank #1, a large concrete structure consisting of one compartment with a 50,000 gallon capacity, is located to the east of Chaput Hughes Ave.. Reportedly sanitary wastes from dwellings on Government Rd., north of Horner Rd., and from the northeastern sewered section including West End Public School are transported through the sewer system to this septic tank. Approximately 100 homes are served by this tank. The septic tank and the area which it serves is shown in the map below.

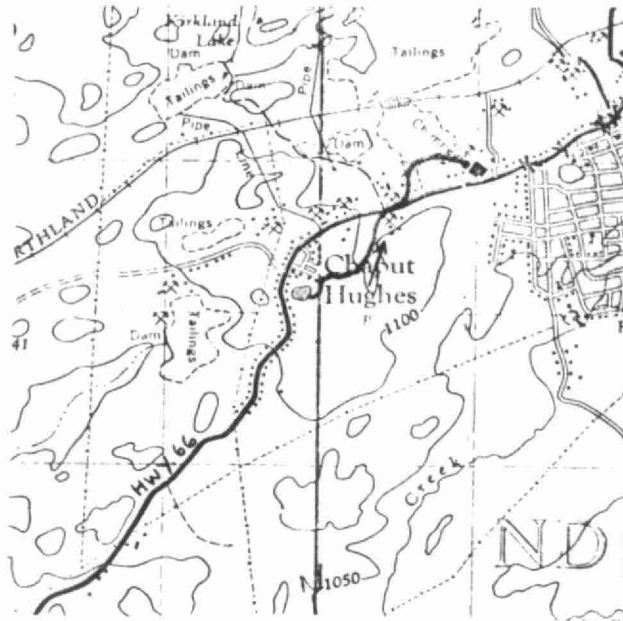
Course which Creek Flows from Origin in Chaput Hughes Pond to Mouth in Pond of Kirkland Lake

A small creek which has its source in a pond located to the south of Chaput Hughes Ave. receives the effluent from this septic tank. The complete course of this creek has been shown in the map below.

A member of the survey team followed the creek from the pond to the point at which it flows under Highway #66. (See the map on the previous page for the approximate location of the creek which passes through this marshy swamp-like pond). A total of four bacteriological samples (SD-3 to SD-6) were taken between the point at which the effluent from the septic tank enters the creek and the point at which the creek flows under the highway; in all four cases the sample results exceeded an 80,000/100 ml total coliform count and an 8,000/100 mls faecal coliform count. A chemical sample from the marsh area was found to have a Kjeldahl of 12.0, accompanied once more by low nitrite and nitrate levels. Organic nitrogen remains as the major nitrogenous constituent in this water. The creek emerges to the west of the inoperative, Teck Hughes Mine shaft and then passes under the highway through a culvert.

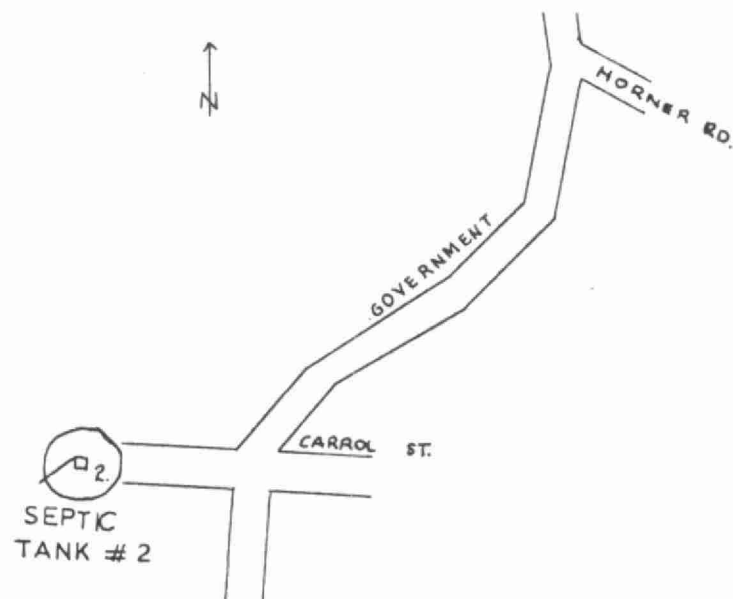
Southern Portion of Chaput Hughes Served By  
Septic Tank #2

The second communal septic tank, which serves an estimated 50 houses in the community, lies west of Carrol St. Wastes received by this septic tank originate in the sewered area of Government Rd., south of Horner Road. The tank is concrete, consisting of one 4,700 gallon compartment. A small map depicting the area served by this tank has been included below.
